THE ULTRASOUND IMAGING OF THE TAPE AFTER TVT PROCEDURE

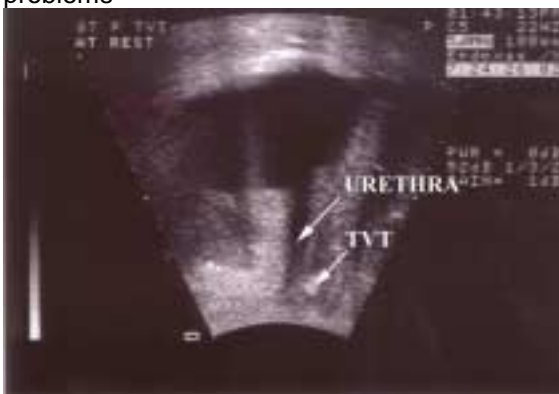
Fig.1a

At rest – women without problems

The ultrasound of the tape imaging was different between the group of women with and without various problems after TVT operation. The most frequent problems included prolonged urinary retention, urinary urge symptoms, and leakage of urine. Figures 1a and b show ultrasound imagings of the lower urinary tract and the tape in women after successful operation at rest and during Valsalva manoeuvre. Figures 2a and b show ultrasound imagings of the lower urinary tract in women after TVT operation with urinary retention and signs of urgency. Figure 2b shows kinking of the proximal urethra during the Valsalva manoeuvre. Figures 3a,b show the correct location of the tape, but with insufficient tension on the left side. The tape is folded which might cause an intermitent leakage of urine. Figures 4a,b show the correct location of the „tight“ tape. This tape compress the urethra against the symphysis pubis [a „pinching“ effect].

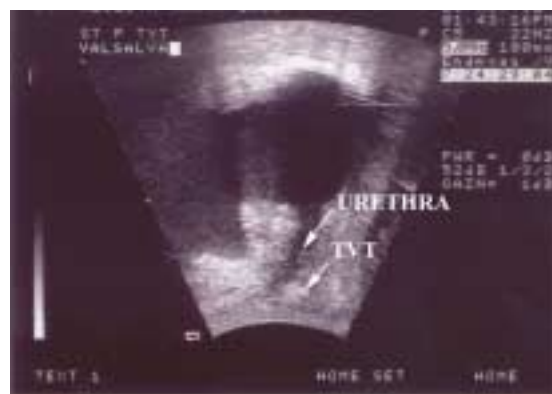
Fig.1b

Valsalva manoeuvre - women without

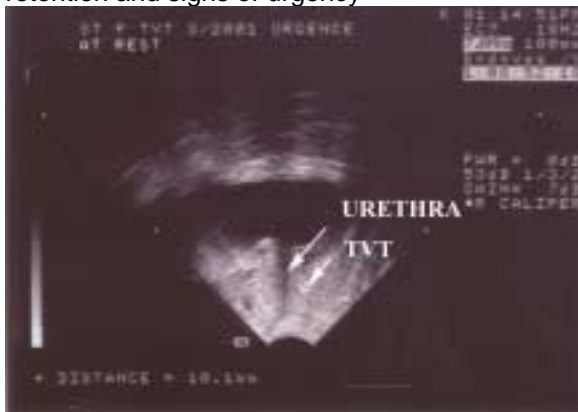
Fig.2a
At rest - women with urinary retention and signs of urgency

The determination of the position and course of the tape during ultrasound examination can help us to find reasons for possible complications of TVT procedure. Incorrect position of the tape and over-elevation of the proximal part of the urethra can cause prolonged urinary retention and signs of urgency. On the other hand, insufficient tension of the tape in its right location can result in intermittent GSI. Implementing US evaluation can give good feedback to surgeons and might help prevent symptoms of urgency, prolonged urinary retention and GSI. When these symptoms occur after TVT procedure, carrying out US examination is a logical step in its management.

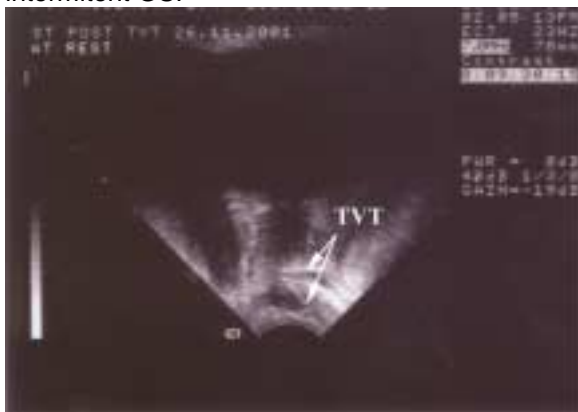
Fig.3a
At rest - women with intermittent GSI

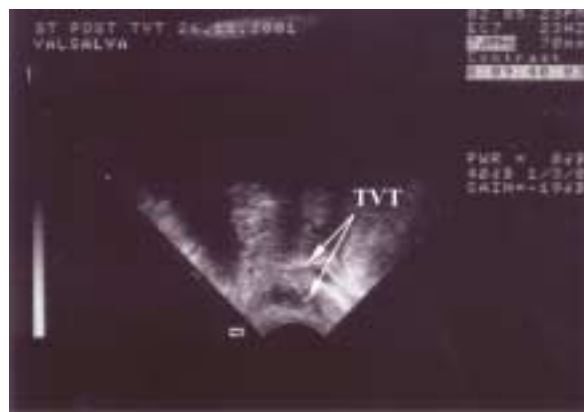
Fig.3b
Valsalva manoeuvre - women with intermittent GSI

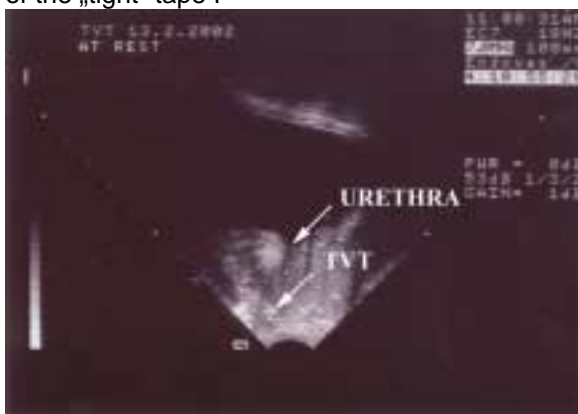
Fig.4a
At rest – the correct location of the „tight“ tape of the „tight“ tape I

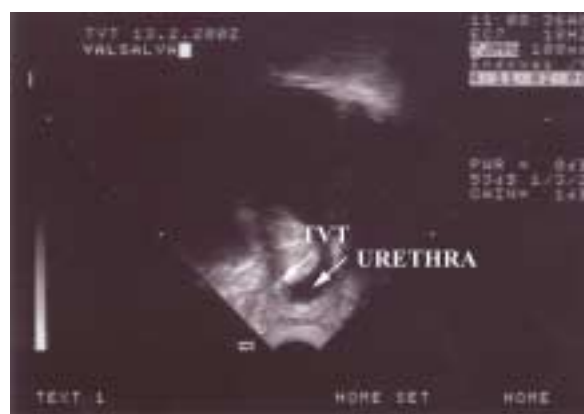
Fig.4b
Valsalva manoeuvre - the correct location
